**Review of Responses to  
NRC Bulletin 2003-02-Leakage  
from Reactor Pressure Vessel  
Lower Head Penetrations and  
Reactor Coolant Pressure  
Boundary Integrity**

Prepared by  
E. Sullivan and G. Cheruvenki

**Division of Component Integrity  
Office of Nuclear Reactor Regulation  
U.S. Nuclear Regulatory Commission  
Washington, DC 20555-0001**

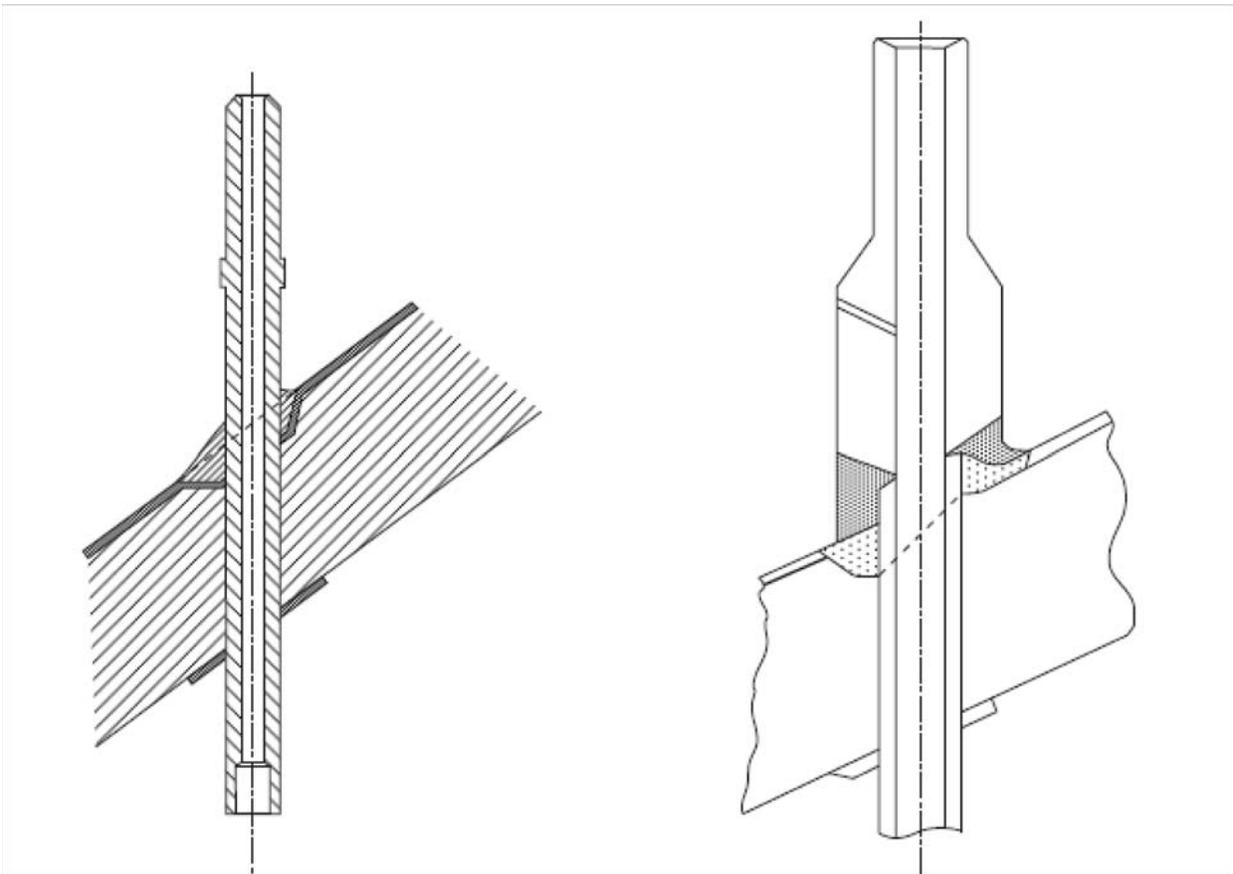
Figure 2-1 Comparison of Westinghouse and Babcock and Wilcox Bottom Mounted Nozzle Design

BMNs were welded to the inside of the reactor vessel bottom head using partial penetration J-groove welds. The J-groove welds were made using either gas tungsten arc welding (GTAW) process with welding wire Alloy 82 (trade name) or shielded metal arc welding (SMAW) process with welding electrode Alloy 182 (trade name). Some J-groove welds were buttered, post weld heat treated (PWHT), then welded to completion without subsequent PWHT. Some J-groove welds were fully welded without butter and subsequently PWHT, depending on the particular unit and fabrication vendor. Some BMNs have circular weld pads surrounding, but not connected to, the BMNs on the outside of the reactor vessel bottom head. Such weld pads were made of either alloy steel, austenitic stainless steel, or Alloys 82/182. A comparison of Westinghouse, B&W, and CE BMN dimensions is shown in Table 2-1 of this section. A comparison of Babcock and Wilcox (B&W) and Westinghouse BMN designs is shown in Figure 2-1 of this section.

By the time of the ONS-1 hot functional test in March 1972, all BMI penetrations had already been installed in the RPV lower head of all seven currently operating B&W units. After the ONS-1 hot functional test, the BMI penetration design was modified to strengthen the BMI penetration portion inside the RPV. The portion of the original BMI penetrations inside the RPV were cut off above the J-groove weld, and replaced by a 2-inch OD. Alloy 600 BMI penetration was attached by a full penetration butt weld. Except for Davis-Besse, the modification was performed in the field without post weld heat treatment (PWHT). Figure 2-1 in Section 2 of this document provides details of this
